# Engine surgery step by step

When Geoff Higginbottom stripped down his underperforming Volvo Penta MD2030 diesel engine he uncovered some expensive repairs

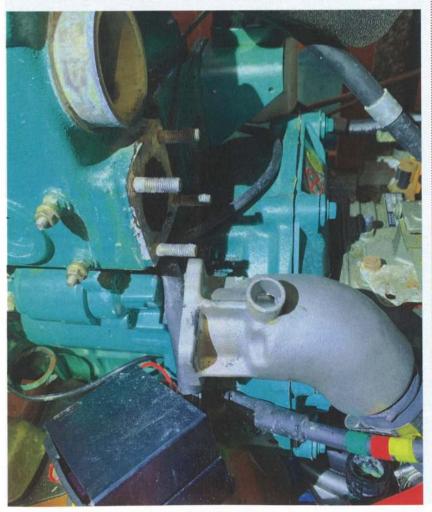
The exhaust elbow and associated rubber boots from the heat exchanger were next to come off, but first I had to remove the electrical box in order to gain access to the heat exchanger's bolts. The insert for the heat exchanger was also removed and set aside for cleaning and inspection.

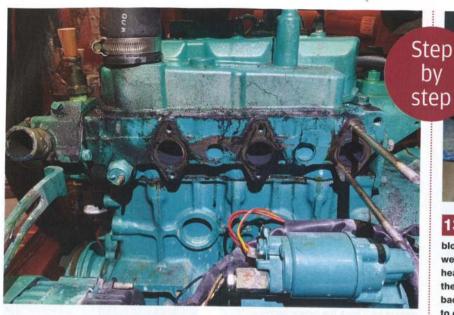
There are two pipes connected to the heat exchanger, one underneath and one at the front, both connecting it to the water pump. These were showing signs of cracking, so I purchased a replacement kit. I could now see that the front one would be very difficult to replace without removing the heat exchanger, so it made sense to get it done immediately.

With the heat exchanger removed, it was obvious that there had been some long-term oil leaks so a full gasket and seal replacement was long overdue. I was now also able to remove the air intake pipe and air filter.

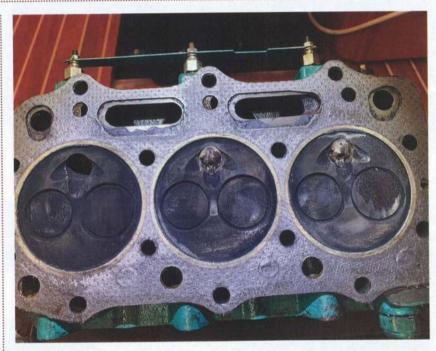
The chambers are sealed with conical inserts containing a number of holes which shape the charge as it enters the cylinder. The foreign object I'd earlier assumed was calcified carbon was in fact the remains of the conical cap for the rear cylinder. The good news was it had remained within the pre-combustion

With the head now removed it was obvious that I had a bigger problem than some simple carbon build-up. Note the gaping hole on the rear cylinder (on the left in this image) which is where the pre-combustion chamber insert should be.

I searched for a second-hand replacement for a couple of months but eventually had to stump up around £1,200 for a new Perkins head.
