# Engine surgery step by step

When Geoff Higginbottom stripped down his underperforming Volvo Penta MD2030 diesel engine he uncovered some expensive repairs

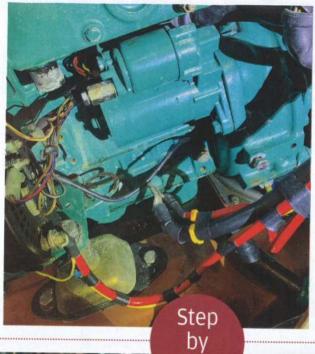
Engine access aboard the Bavaria 39 is excellent once the companionway steps are removed. But I regretted not getting around to fitting those engine room lights, so broke out the head torch to see what I was doing.

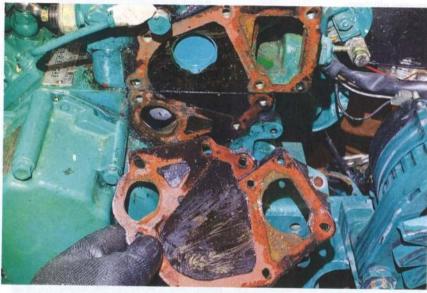
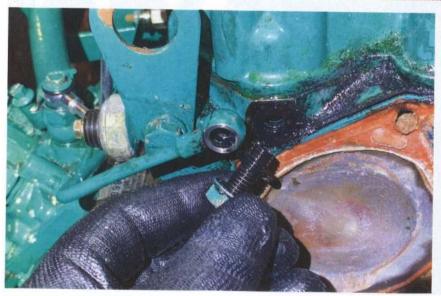
With all the bolts removed from the water pump, I was able to tease it off the engine, but there was still the backing plate to think of. It's tempting to use screwdrivers to prise it off but that method can damage the mating surfaces. It's best to tap it gently all round with a dead-blow hammer.
